Manhole Inspection Summary

Manhole # S39KK_029MH

Location Address: **1840 ENSOR ST**

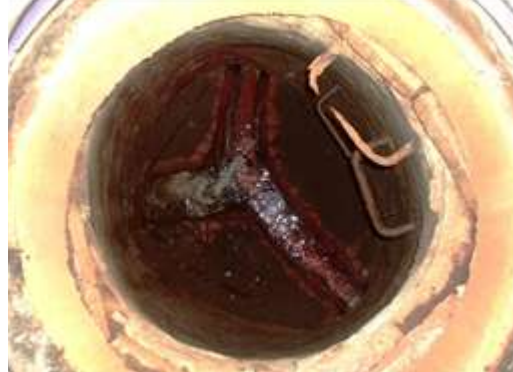
Top View

Corroded and missing steps. Evidence of surcharge - Bench debris. Channel debris.

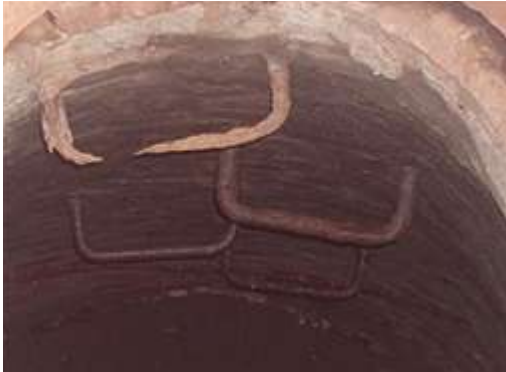
Defect

Corbel infiltration.

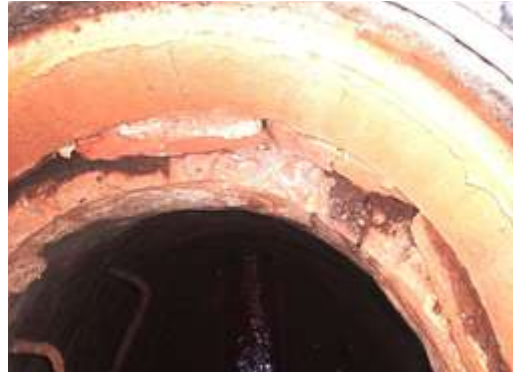
Defect

Frame leaks. Frame offset. Adjustment deterioration and infiltration. Corbel infiltration.

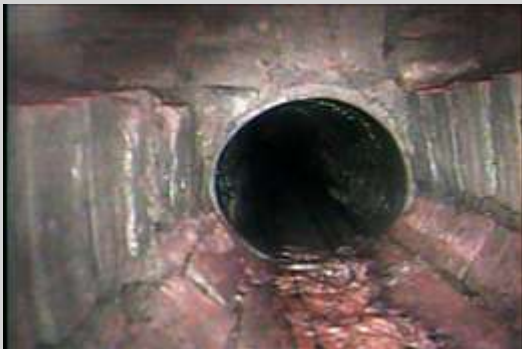
8 in. Circular Gravity Sewer Pipe In @ 4 O'Clock

Channel deterioration.

Infiltration: **None** Pipe Seal Cond: **Cracked**

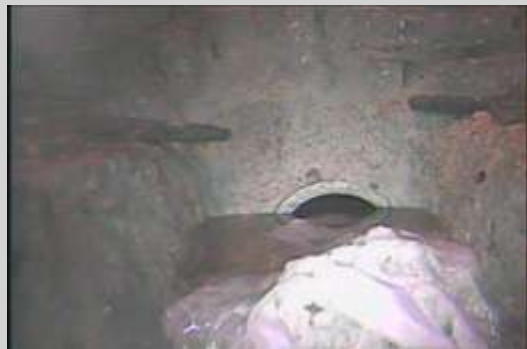
6 in. Circular Gravity Sewer

Deposits: ☐ None ☐ Mud ☐ Sludge ☒ **Debris** ☐ Grease

Silt Depth: **5** (in.) Deposits Extent: **Heavy**
